UWP 3.0 Tool Download

Tips & Tricks

Index

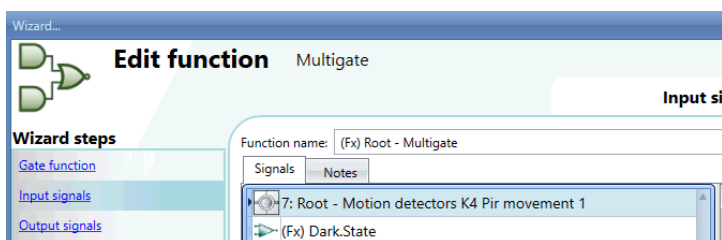
Energy save timer is not reloaded when the light level is above the threshold

At this point the lux value goes above the threshold and the energy save timer is not reloaded anymore, therefore the light goes off even if there is presence in the room.

Create an external analogue comparator that is used to define the "dark" condition. Use the comparator function as input of a multigate "AND" function combined with the *movement signal* of the PIR sensor.

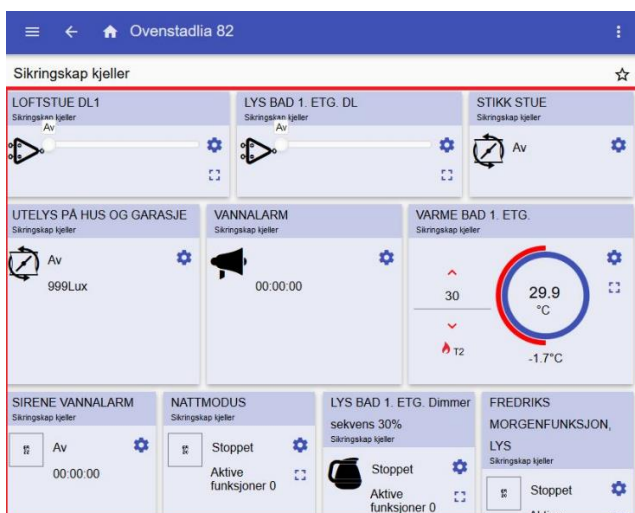
Wrong icons shown in the web App

After a firmware upgrade of the system the icons in the web App are not correct (the icons are messed up or missing).

The error is due to the cache of the web browser, the issue will be resolved cleaning the cache and logging-in again in the web App.

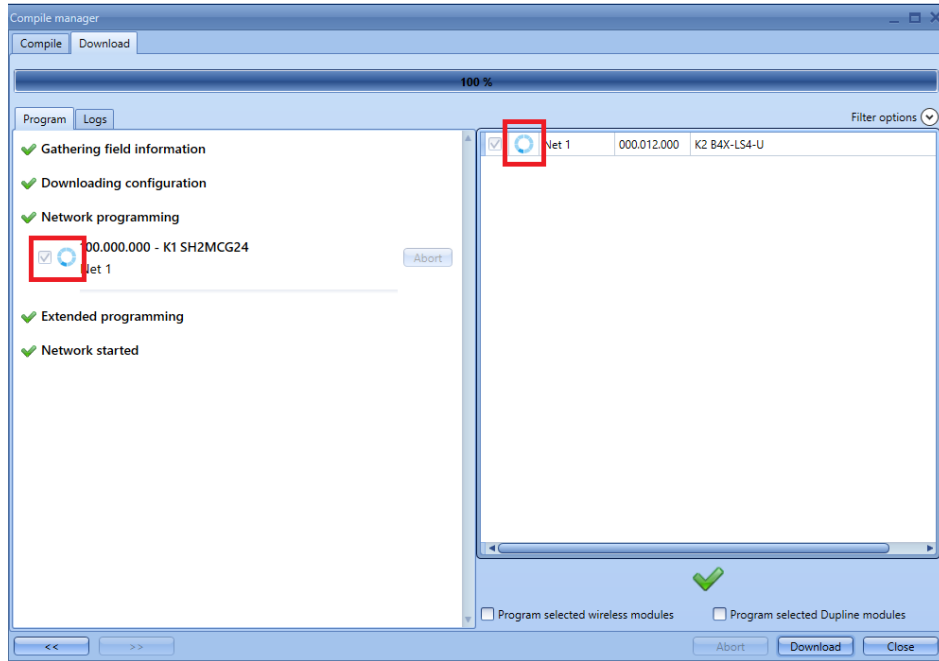
Download configuration shows 100% but the modules icons are not updated

The *Download* of the configuration leads to an issue in the *Download manager* window: the icons next to the modules keep spinning even if the progress bar shows 100%.

Delete all the *Multigate* functions without input signals from the project.

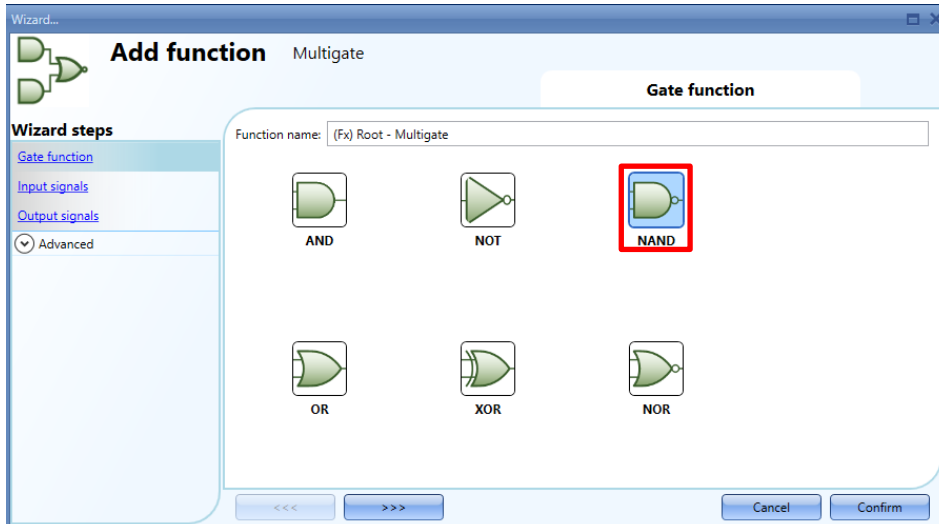
This problem occurs every time a project contains a *Multigate* function that is configured as NAND operator without input signals (the *Input signals* window is empty).
