UWP 3.0 Tool Download

Tips & Tricks

Index

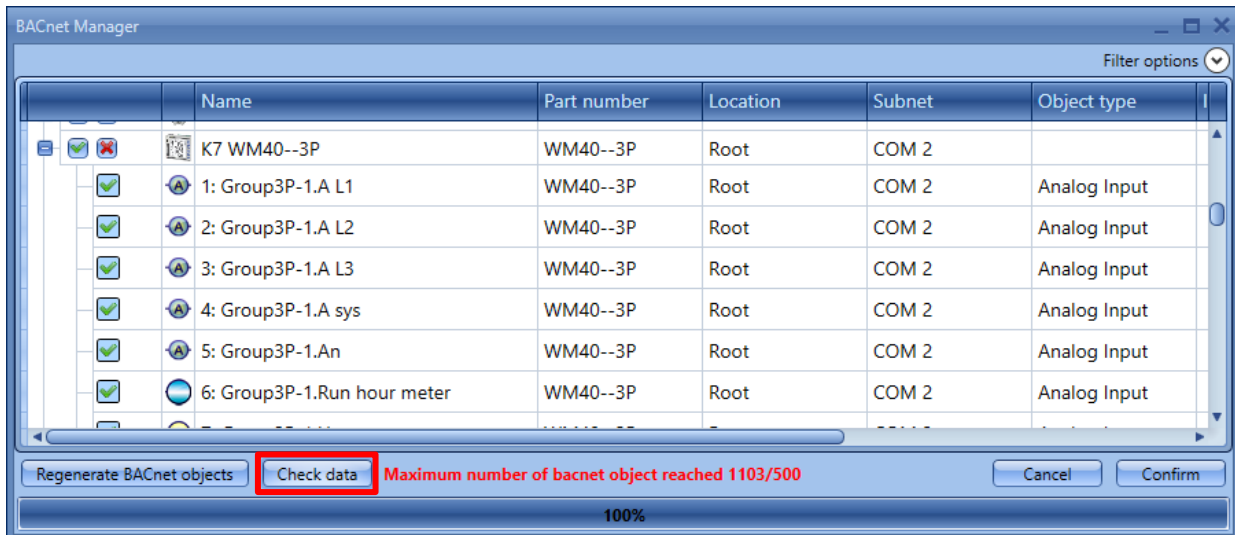
To check if a project complies with this limitation, click on *BACnet management* icon in the *Program Setup* menu, then click on **Check data** button:

As shown in the example above, a warning message will be displayed if the maximum number of BACnet Objects has been exceeded and their amount; otherwise the **Ok** message will be displayed when it is compliant.

Note: It is mandatory to delete the excess BACnet Objects and compile the configuration before sending the project to the UWP 3.0 controller.

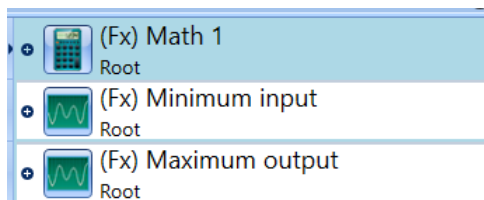
In the Database window, the additional function status of a function is not available and it is not possible to log them into the Database of the system.

- a. Add to the project one Analog Output function for each additional status not available in the Database.

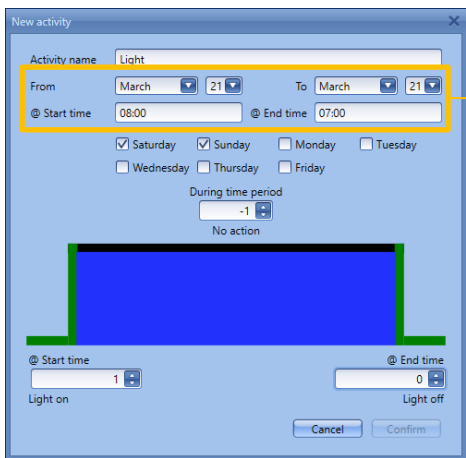
This happens if at least one of the following conditions is verified:

The *Activity name* field has to be entered

At least one week day has to be selected

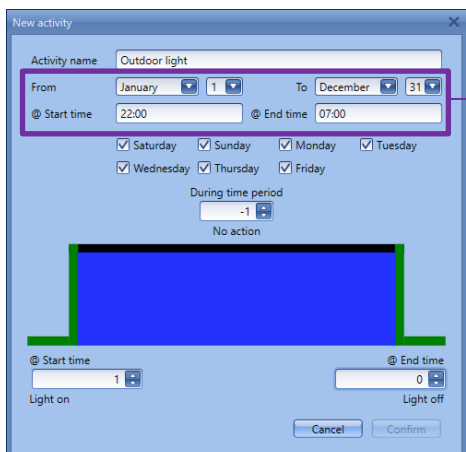
a) With the same selected interval date (*From... To...*), it is necessary to set *@Start time* chronologically prior to *@End time*
